Report No. 0270-07-17309

Testing and Examination of Pipe from
Dixie Pipeline Company's
12-inch Hattiesburg, MS to Demopolis, AL Pipeline

T. V. Bruno

March 30, 2007

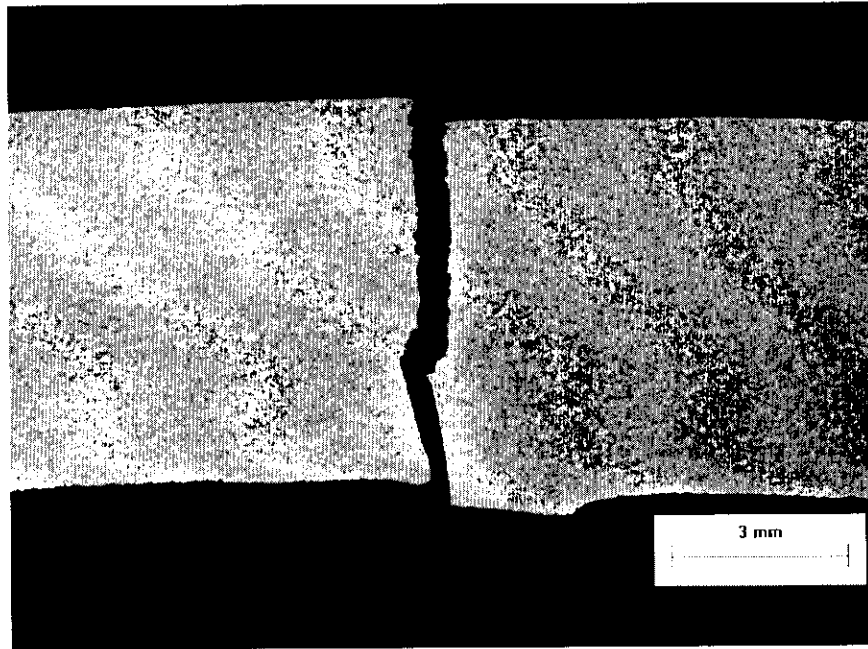
The fracture initiated at a hook crack on the inside surface, which is shown in Figure 5. The hook crack was approximately three inches long, and at its deepest was 0.13 inch deep, which is 49 percent of the wall thickness. Other hook cracks were evident along the length of the fracture, separated by brittle fractures. The hook cracks were located near each surface and near midwall. One of the hook cracks, shown in Figure 6, was at the reported USCD indication. Figure 7 shows a typical hook crack upstream of the fracture origin.

Typical hook cracks upstream from the failure origin.

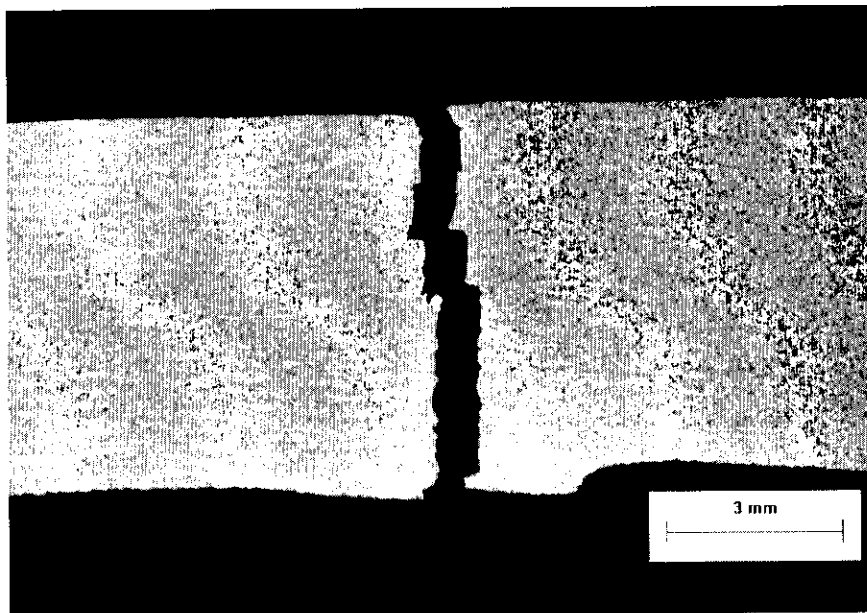
Figure 8 Joint No. 6105 8X
Nital Etch

Matching transverse sections from the hook crack shown in Figure 5.

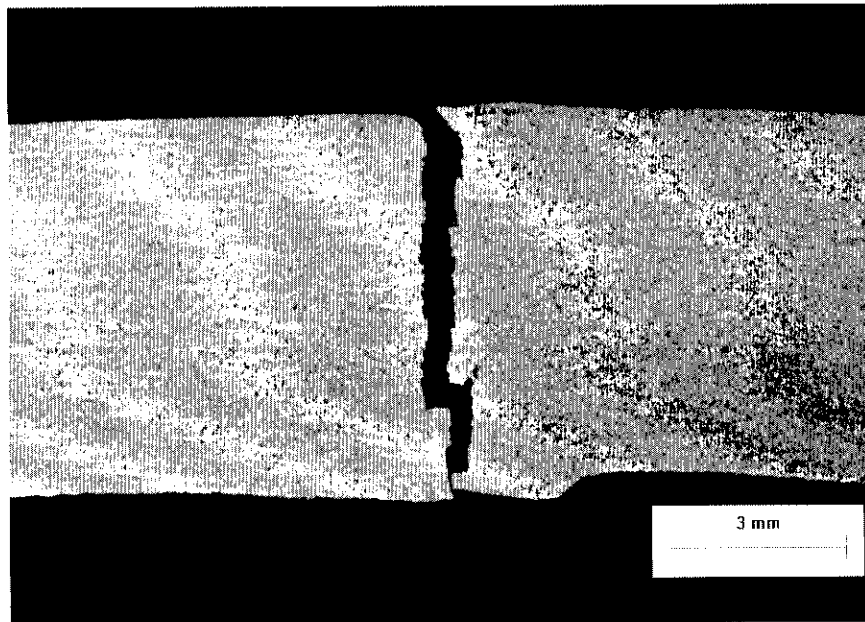
Figure 9 Joint No. 6105 8X
Nital Etch

Matching transverse sections from the hook crack shown in Figure 6.

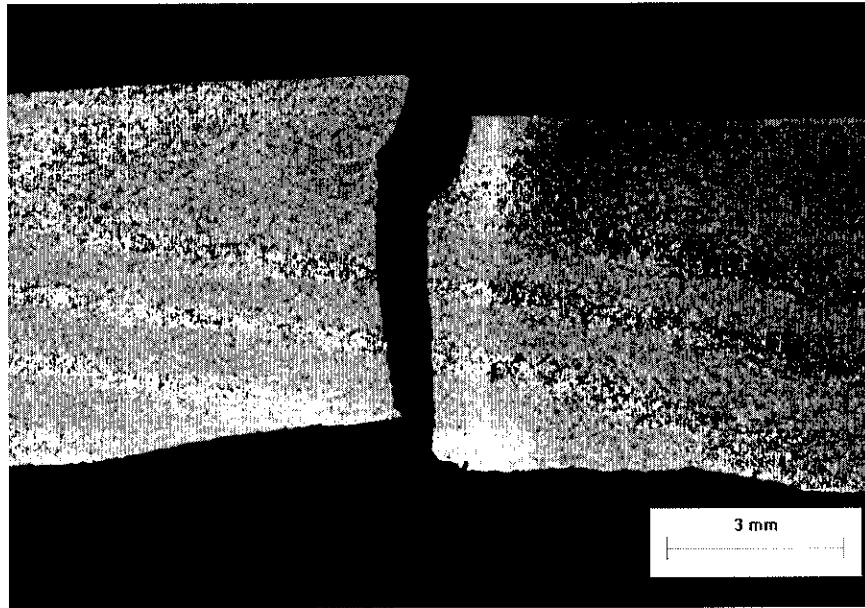
No fracture origin was apparent on the fracture surfaces. The most prominent flaw was a hook crack on the outside surface that extended for several inches, and was deepest at 12 feet, 4 inches, as shown in Figure 15. (Note that in Figures 15 through 17 the outside surface is at bottom.) Other hook cracks were apparent along the length of the fracture as well as black spots. Many of the black spots were located in the length of the reported USCD indication, some of which are shown in Figures 16 and 17. The deepest flaw found along the fracture is indicated by the arrow in Figure 17; it was 0.19 inch deep or 79 percent of the measured wall thickness.

Photographs showing typical black spots on the outside surface (at bottom). The arrow in Figure 17 indicates the deepest flaw.

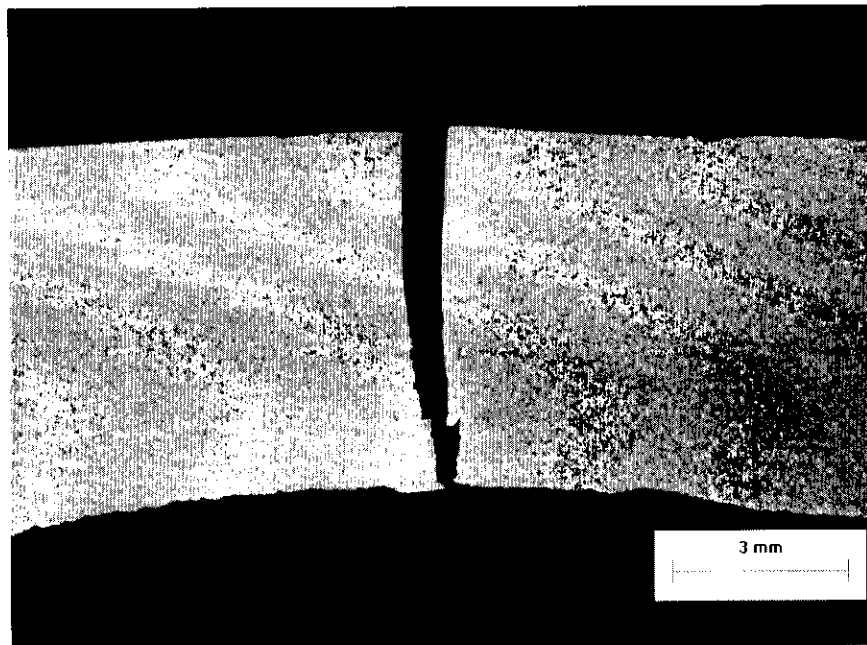
Figure 19 Joint No. 2797 25X
Hot Picric Acid Etch

Outside surface of the hook crack after etching. The arrow indicates the weld line.

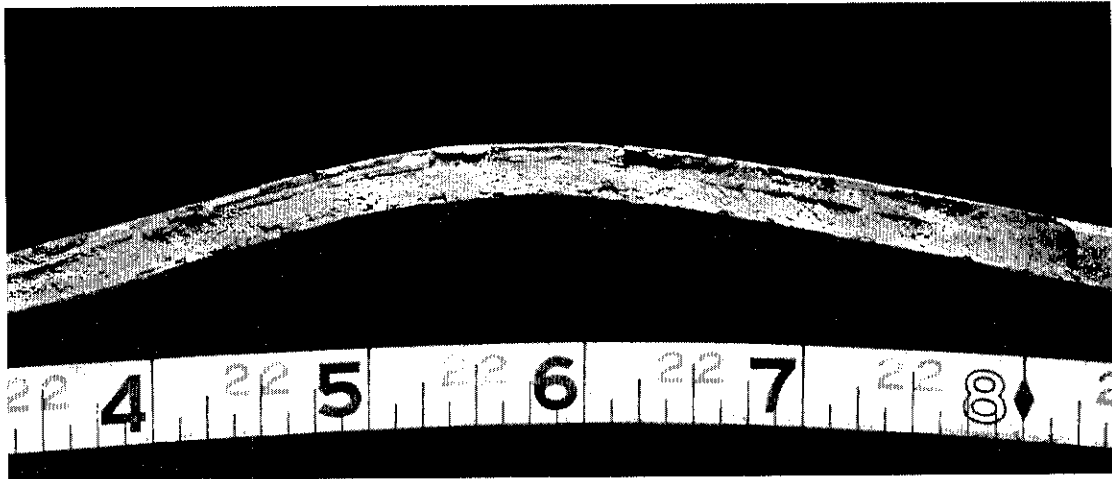
Figure 23 shows the rupture in Joint No. 324, which extended from 20 feet, 5 inches to 37 feet. There was one USCD indication 2-1/2 inches long reported along the fracture length, at 22 feet, 6 inches. The reported indication coincided with the apparent fracture origin at a hook crack on the outside surface, shown in Figure 24. In addition to a bulge, chevron patterns (not included in Figure 24) could be seen on each side of the hook crack, pointing to it as the failure origin. The maximum depth of the hook crack was approximately 0.10 inch, which was 37 percent of the measured wall thickness.

Photograph showing the rupture in Joint No. 324.

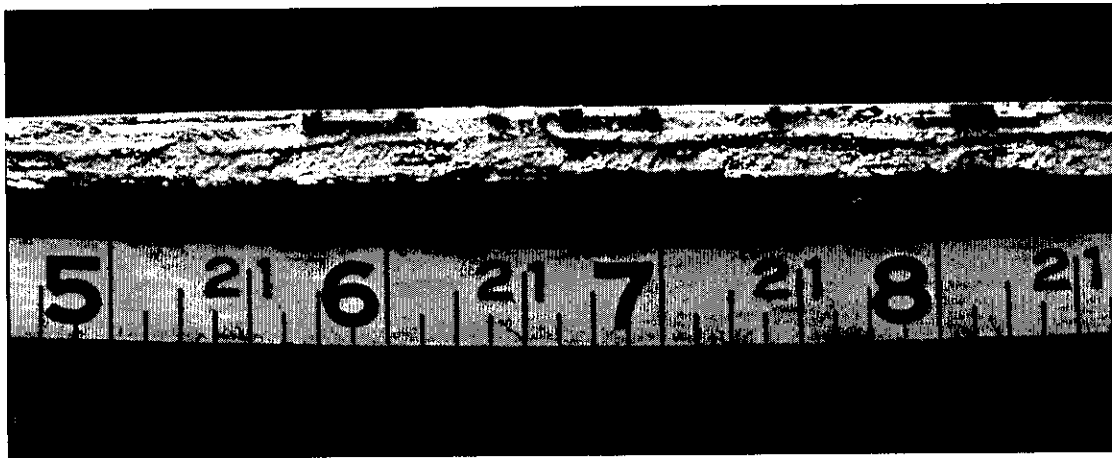
Figure 24

Photograph showing a hook crack at the outside surface at the apparent origin.

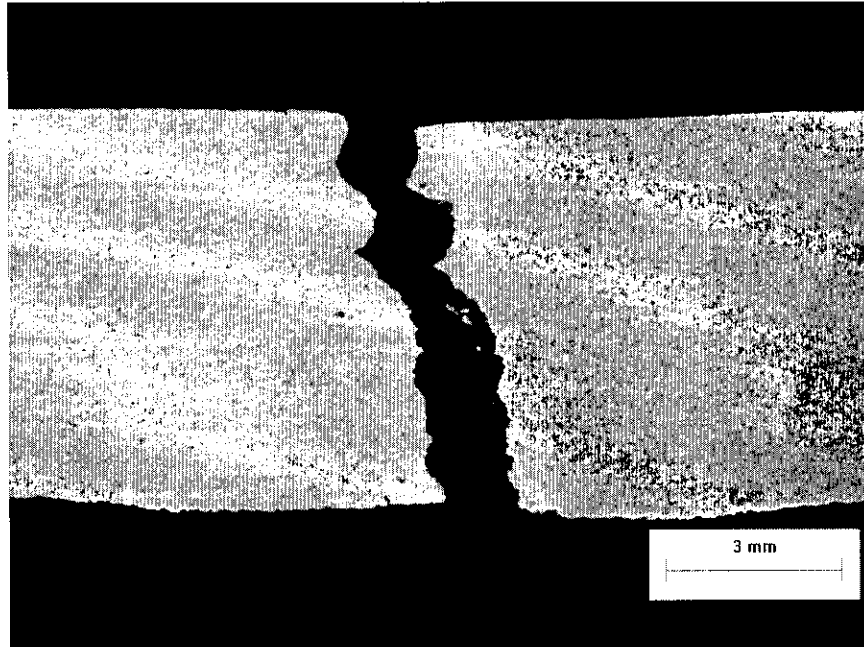
Figure 25

Other hook cracks were apparent along the length of the fracture, a typical example of which is shown in Figure 25.

Photograph of a typical hook crack found along the rupture.

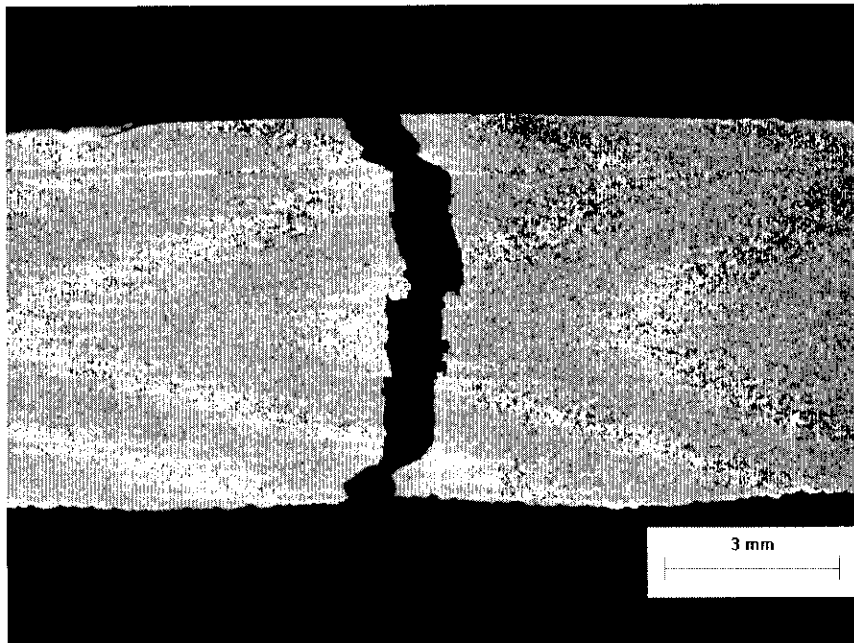
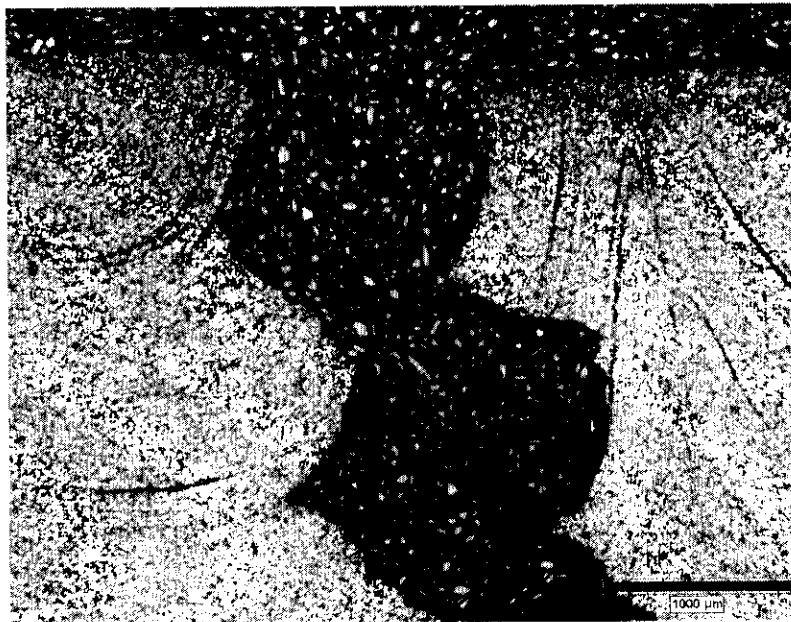
Figures 26 and 27 show the matching transverse sections from the origin and the other hook crack, respectively, and Figure 28 shows the hook crack at the origin etched with hot picric acid.

Figure 26 shows the sections from the hook crack at the apparent failure origin, and Figure 27 shows the sections from the hook crack shown in Figure 25.

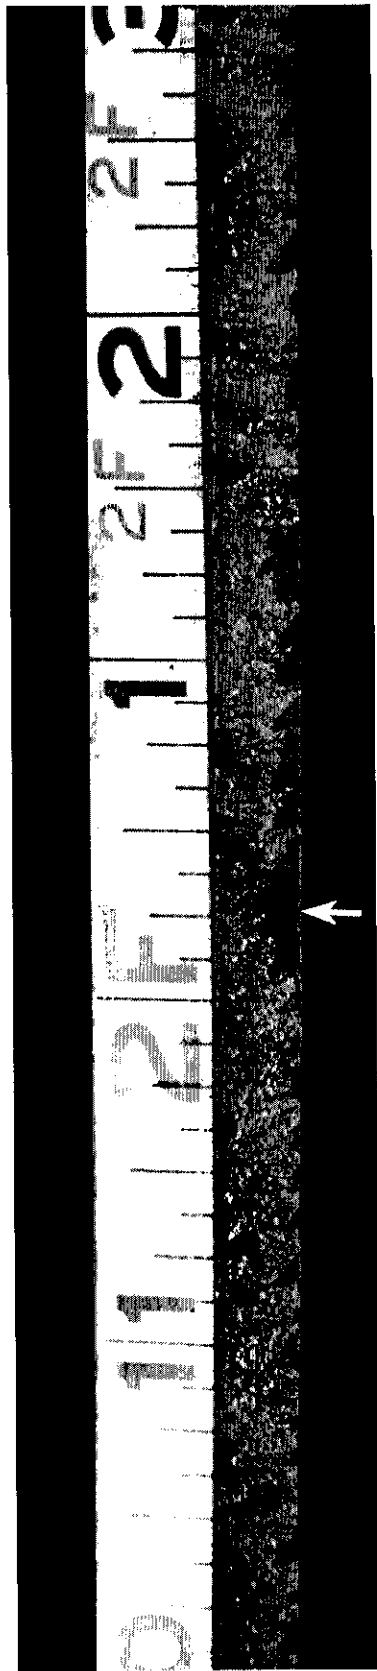
Figure 29

The rupture in Joint No. 6903, shown in Figure 29, had propagated across the upstream girth weld for two inches, and extended 14 feet, 7 inches beyond it to 14 feet, 5 inches. The fracture origin was not apparent, and the fracture in this joint was unusual in that there were no indications of hook cracks. Most of the fracture appeared brittle, with black spots present in groups along the length of the fracture, mostly on the outside surface.

Photograph showing the rupture in Joint No. 6903.

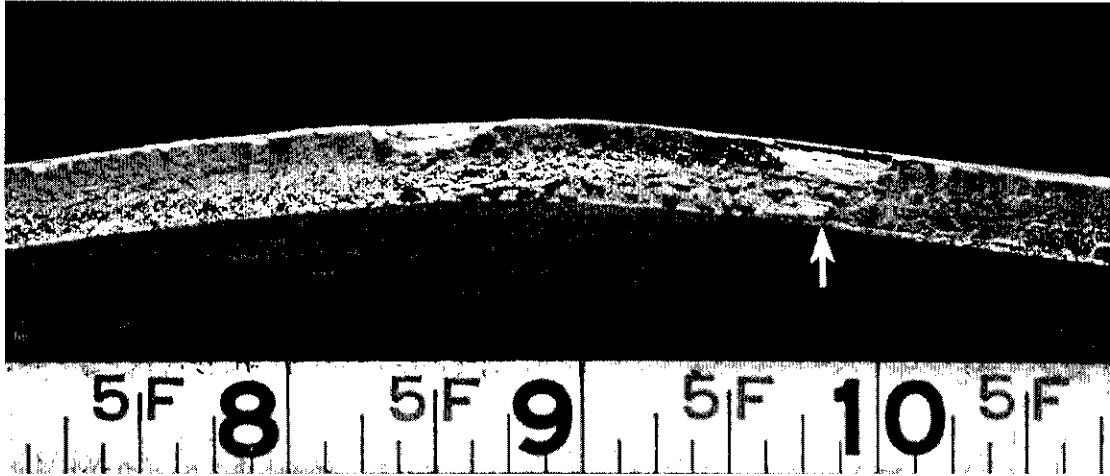
The rupture in Joint No. 6106, shown in Figure 36, extended from 2 feet, 5 inches to 8 feet, 3 inches. There was a bulge near the middle of the rupture and slight post-rupture mechanical damage at the outside surface at the bulge. Two small flaws were apparent on the fracture surface in the bulged area at which the fracture

Photograph showing the rupture in Joint No. 6106.

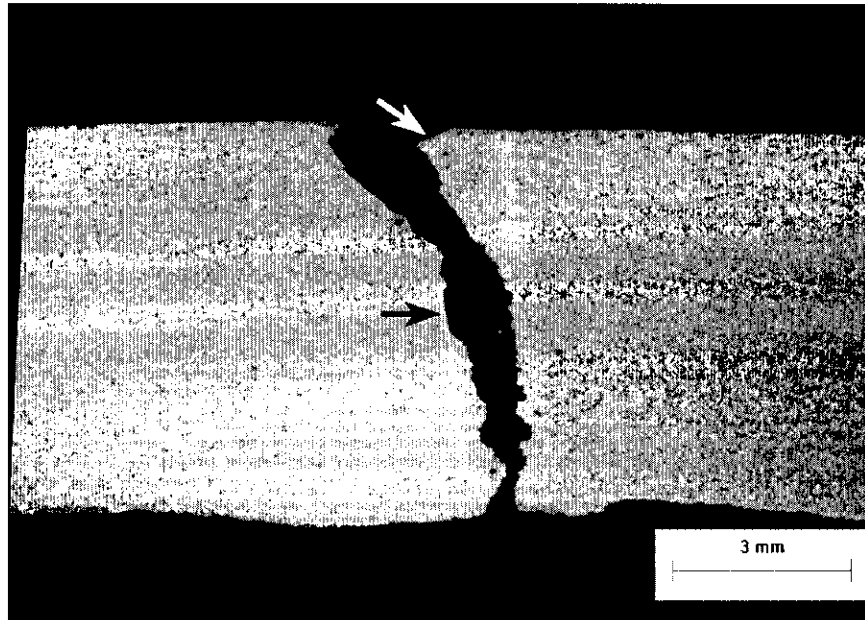
may have initiated, which are shown in Figure 37. There was one reported inspection indication in the fracture length, at 4 feet, 6 inches, which appeared to be a hook crack and is shown in Figure 38. This was the deepest flaw in this joint, and was 0.15 inch deep, which is 55 percent of the measured wall thickness. At other locations the fracture surface was rough and irregular, with evidence of many small discontinuities.

Photograph showing the fracture surface at a reported PAUT indication. The arrow indicates a location from which a metallographic section was taken.

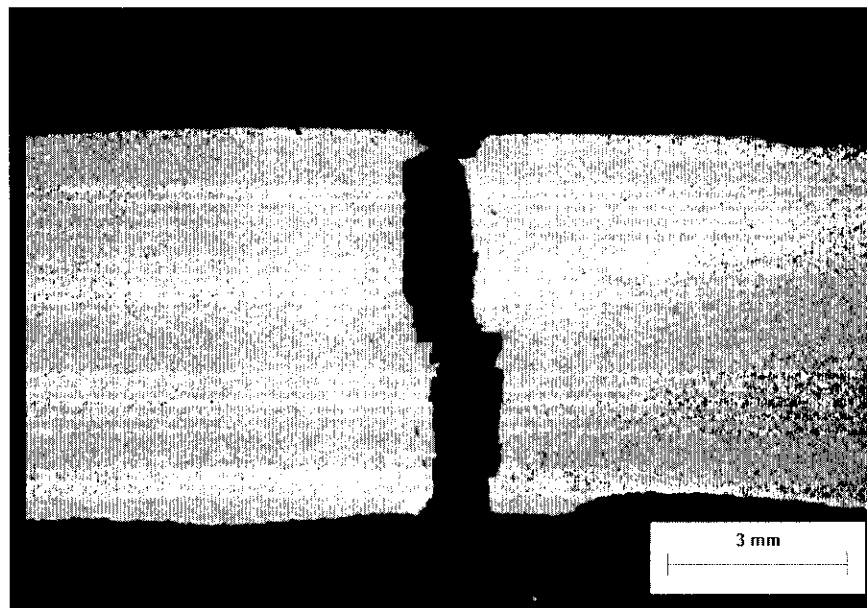
Matching transverse sections were taken from one of the apparent flaws at the bulge, and from the hook crack at the reported inspection indication. Figures 39 and 40 show the sections from the flaws indicated by the arrows in Figure 37 and 38, respectively. Neither specimen showed a heat-affected zone, indicating they were from Lone Star Steel pipe. The sections at the bulge, Figure 39, did not match very well because of the mechanical damage on one side, white arrow. The fracture at this location appeared to have started along the weld line, black arrow, and broke at an angle across the base metal at the inside surface.

The part of the fracture in the specimen from the hook crack, Figure 40, was relatively straight, but at higher magnification much of the fracture was along the fiber lines next to the weld. However, the fiber lines were not as pronounced as were those in some of the other Lone Star Steel pipe.

Matching transverse sections from the locations indicated by arrows in Figures 37 and 38, respectively. The white arrow in Figure 39 indicates mechanical damage, and the black arrow indicates the weld line.

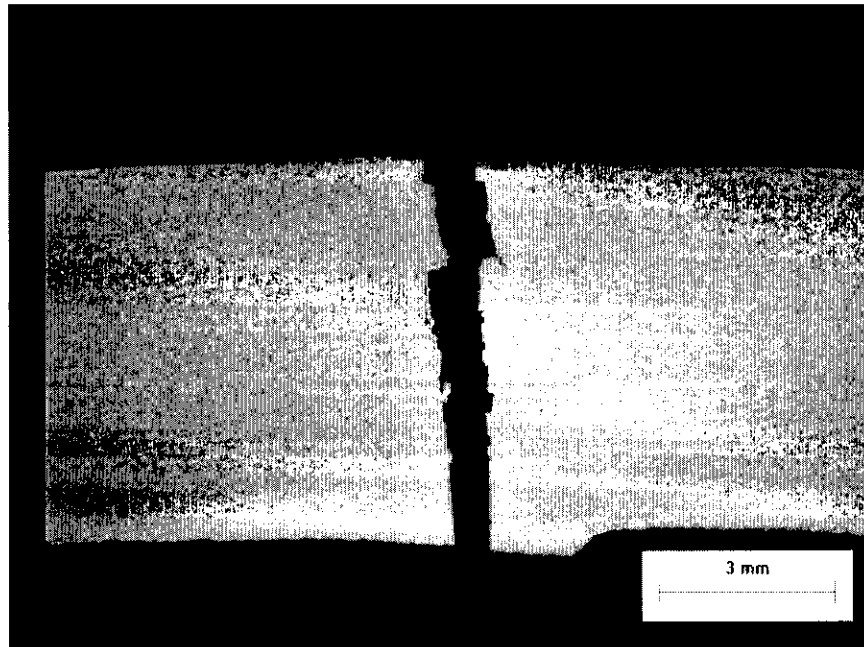
Figure 42 shows the hook crack at the outside surface at the failure origin, and Figure 43 shows typical black spots at the inside surface.

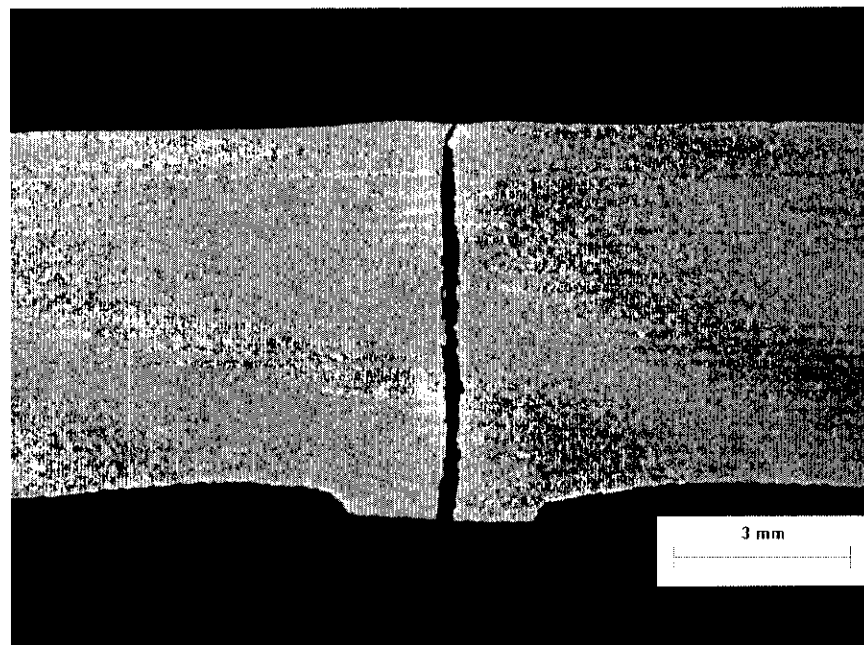
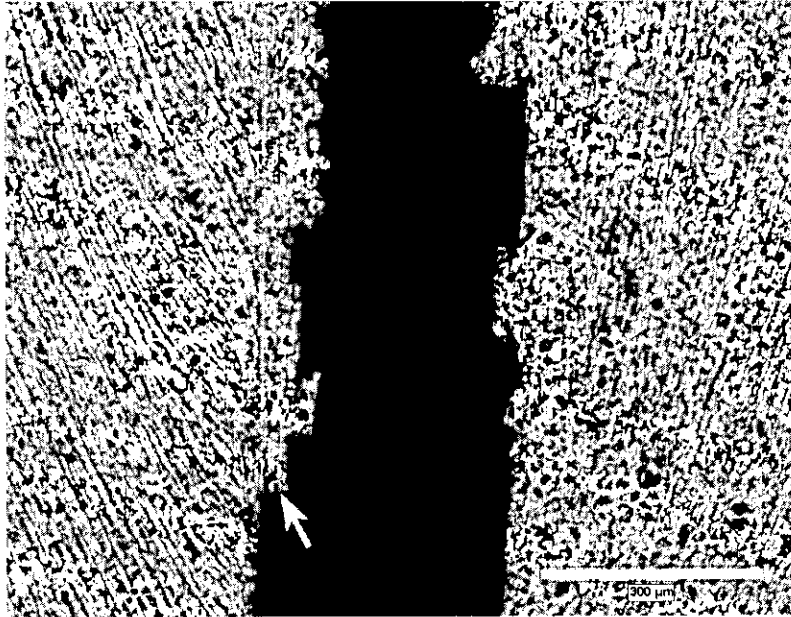
Figures 44 and 45 show matching transverse sections from the failure origin and one of the black spots, respectively. When etched with hot picric acid, the hook crack at the origin appeared similar to the hook crack shown in Figure 12. In contrast, the specimens from the black spot showed flat, smooth surfaces along the weld line at the black spot, which was on the outside surface, that became more

Matching transverse sections from the hook crack and one of the black spots shown in Figures 42 and 43, respectively.

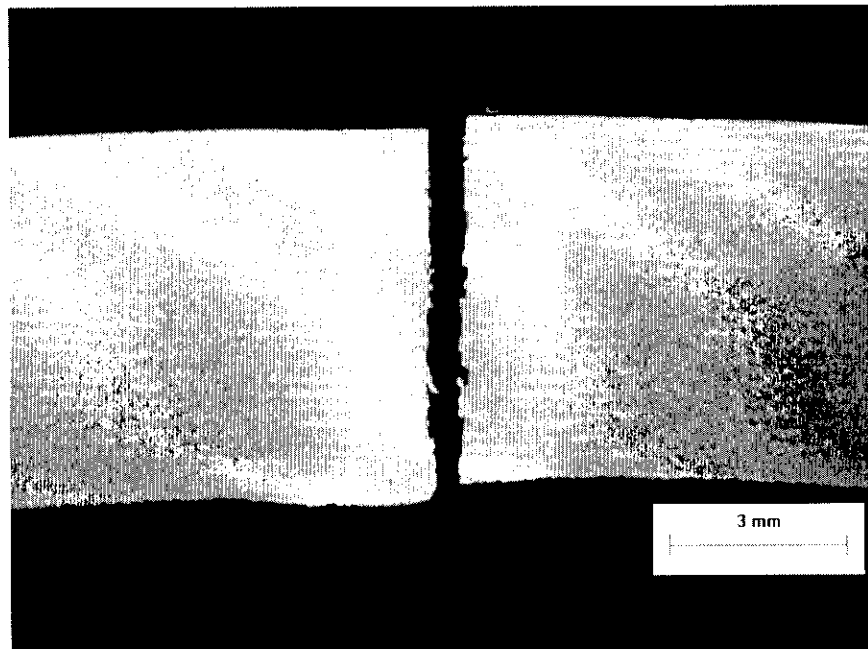
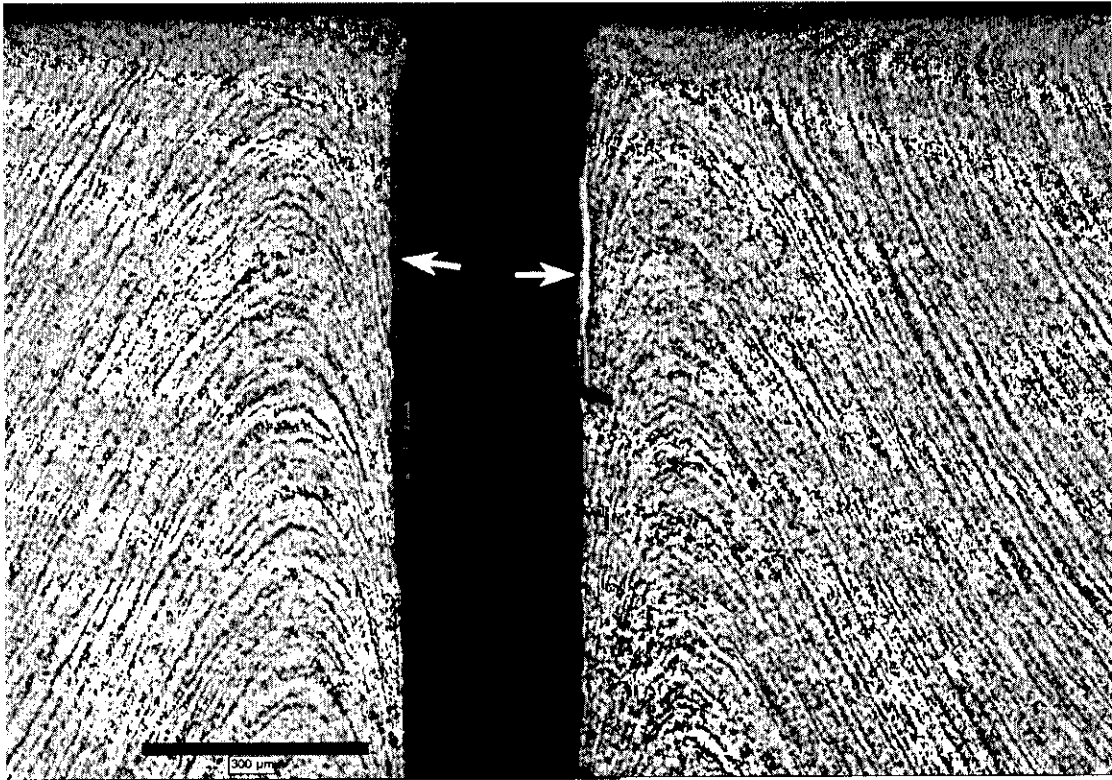
Matching transverse sections from the large black spot shown in Figure 49 and the hook crack shown in Figure 51, respectively.

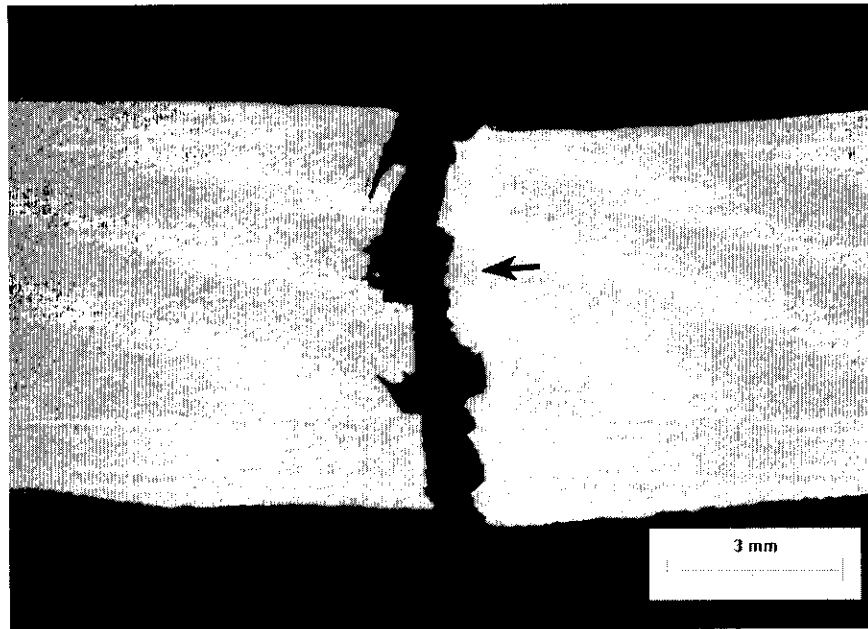
Figure 57 shows a typical location with hook cracks and multilayer fracture surface, and Figure 58 is a closer view of part of the fracture.

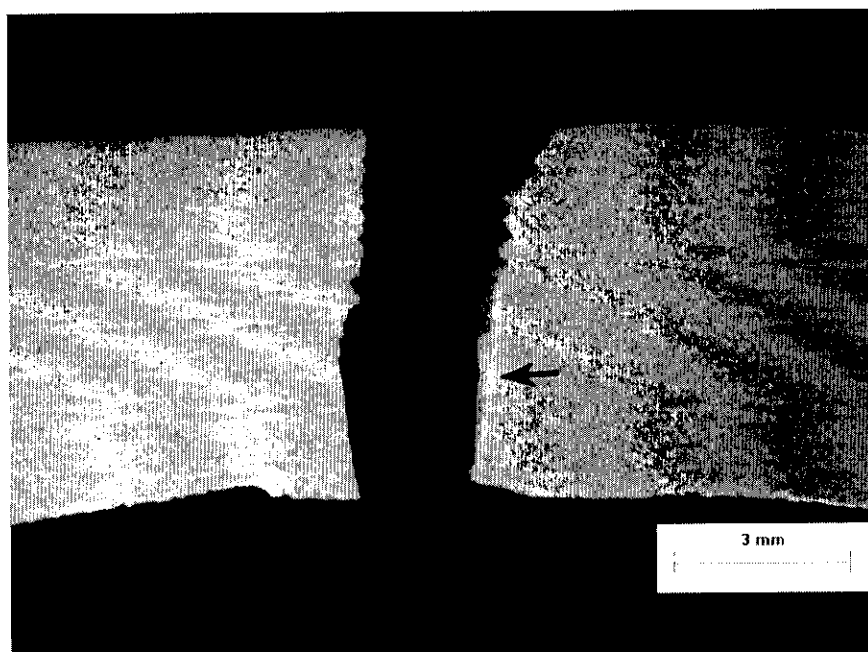
Figure 61 shows a hook crack on the inside surface at the failure origin, and Figure 62 shows the fracture at the location of a reported USCD indication (45 feet, 7 inches).

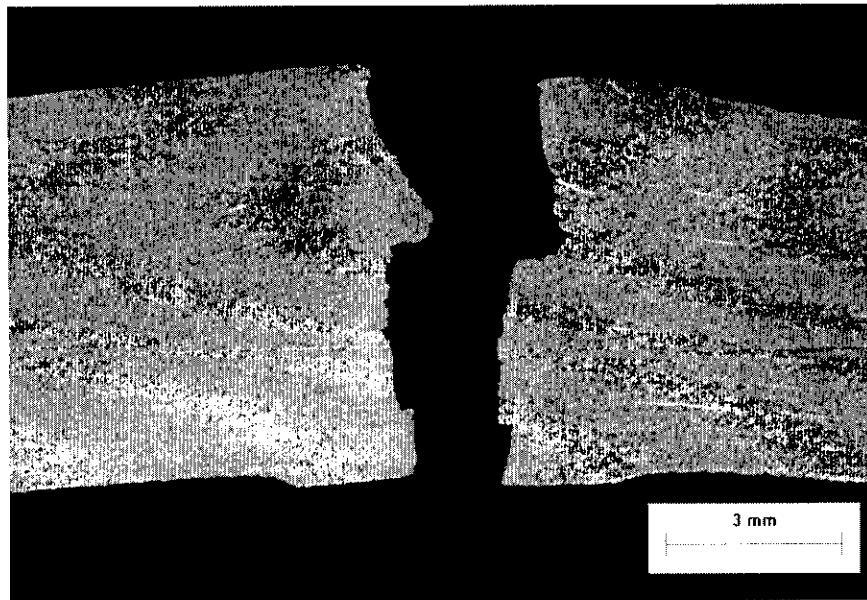
Photograph showing a typical location with hook cracks and brittle fractures.

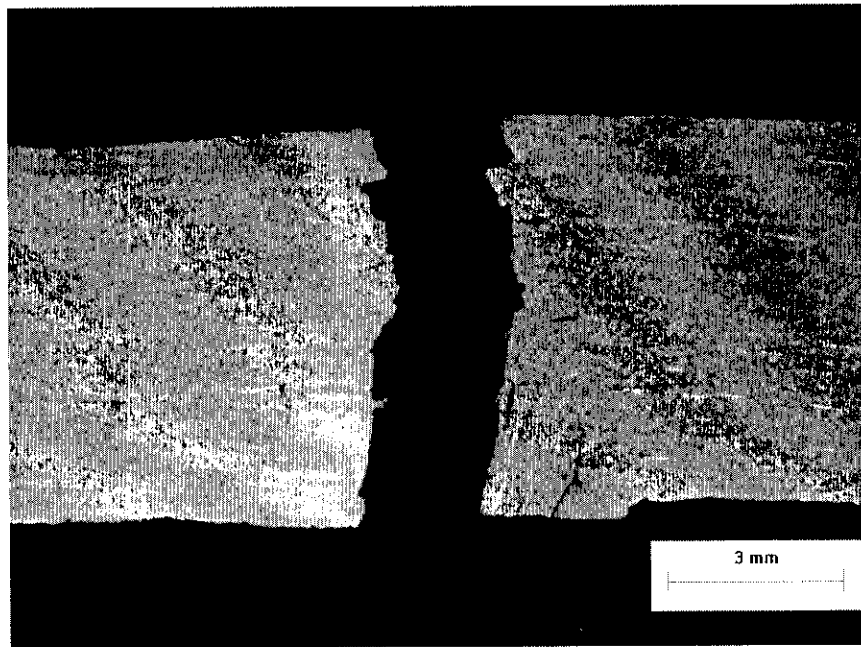
Photographs showing hook cracks on the fracture surface at the other two reported USCD indications.

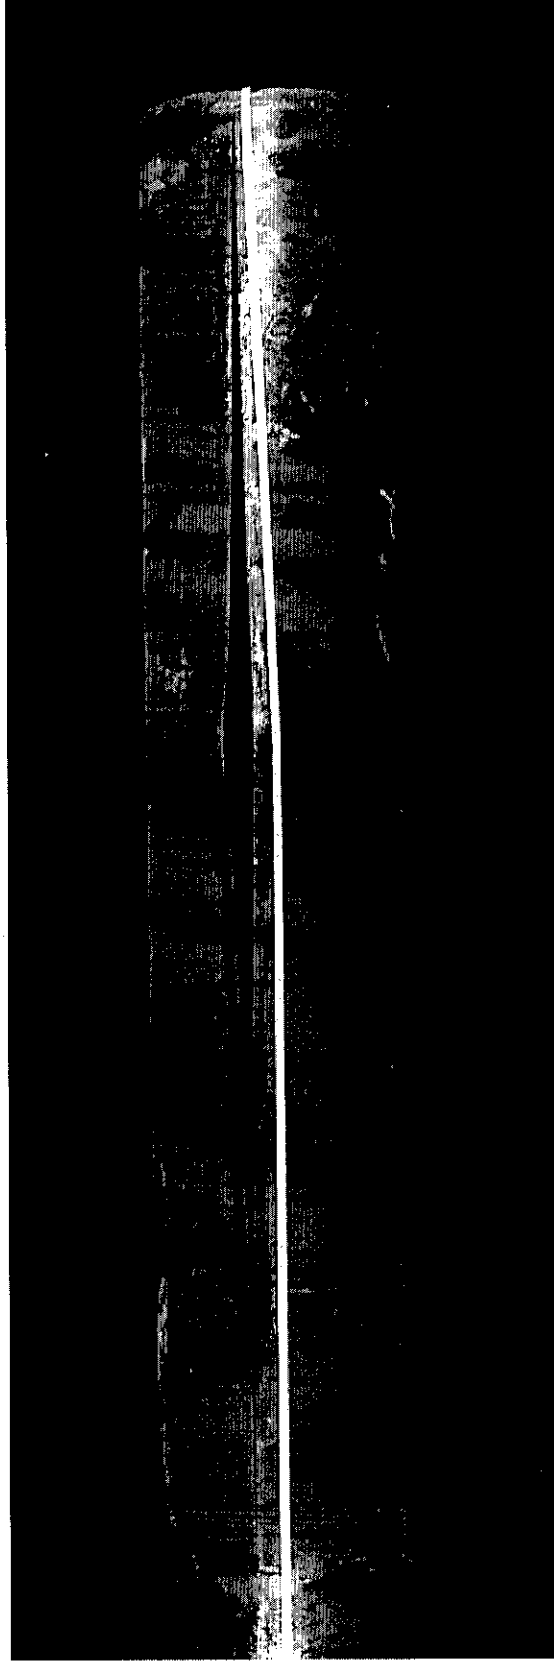
Figure 72 Joint No. 10737 8X
Nital Etch

Matching transverse sections from the hook crack shown in Figure 69.

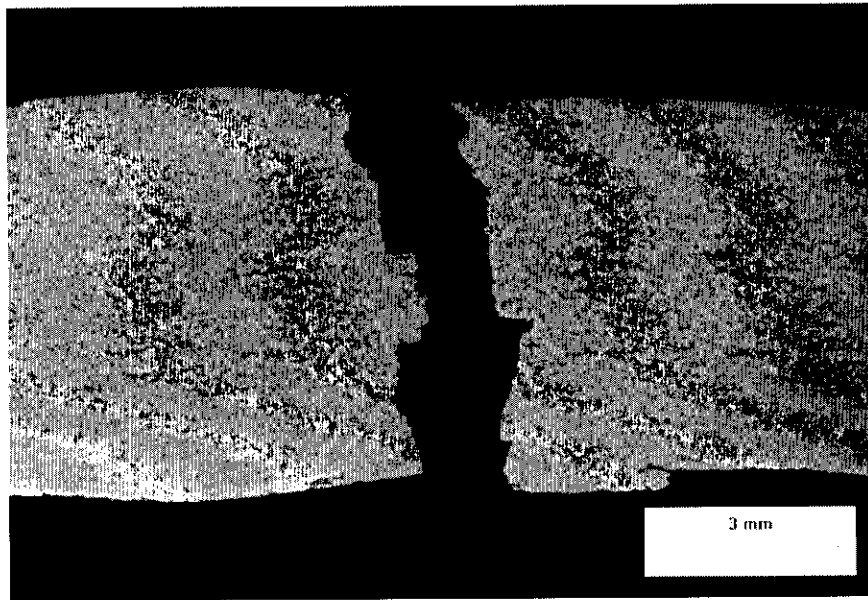
Photograph showing a fracture area with black spots at the inside and stitching along the outside surface.

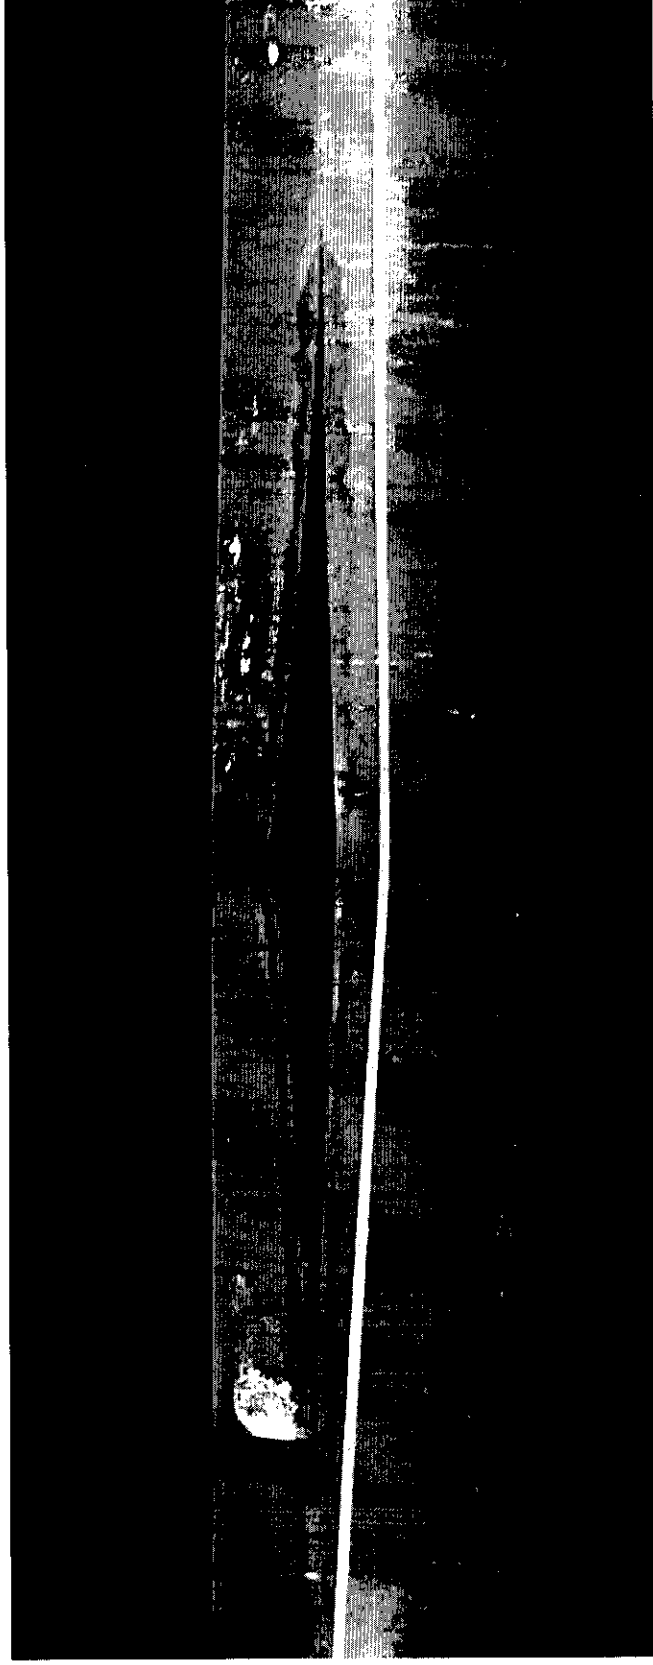
Figure 76 Joint No. 7757 8X
Nital Etch

Matching transverse sections from the fracture origin.

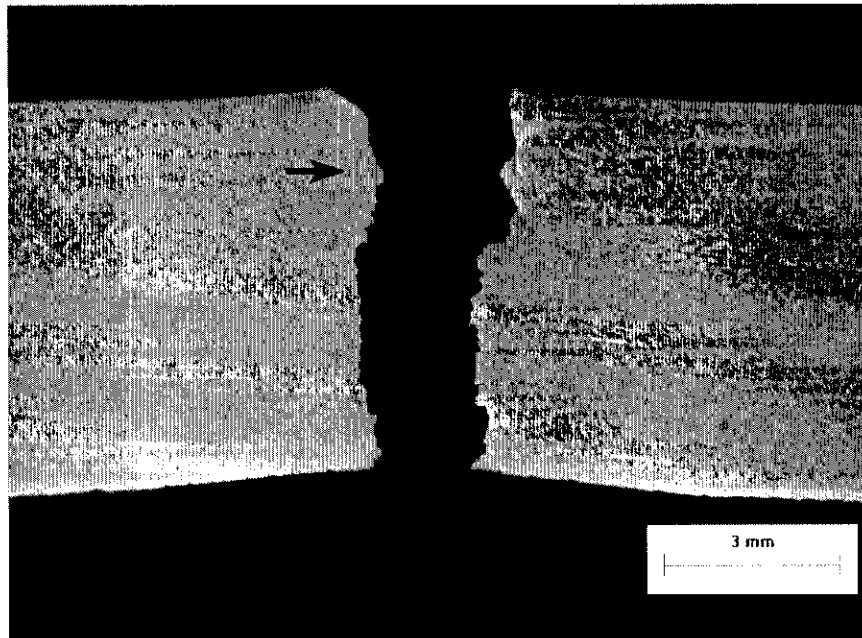
Figure 78 shows the fracture at the failure origin, and Figure 79 shows a typical area of brittle fracture and hook cracks.

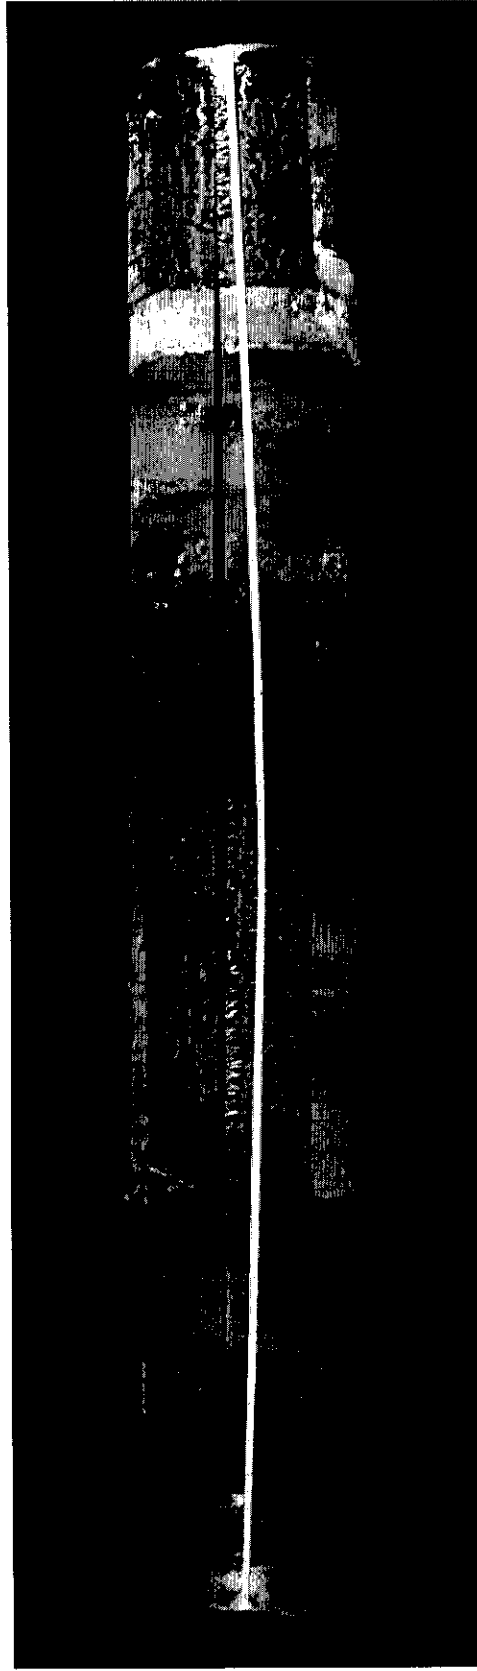
Figure 80 Joint No. 3897 8X
Nital Etch

Matching transverse sections from the failure origin, with an arrow indicating the weld line.

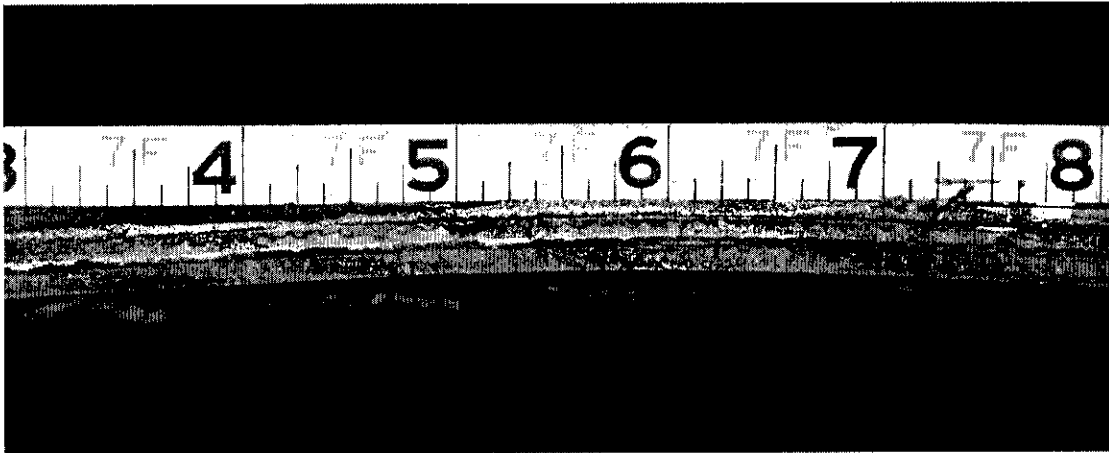
Figure 81

Photograph showing the rupture in Joint No. 5204.

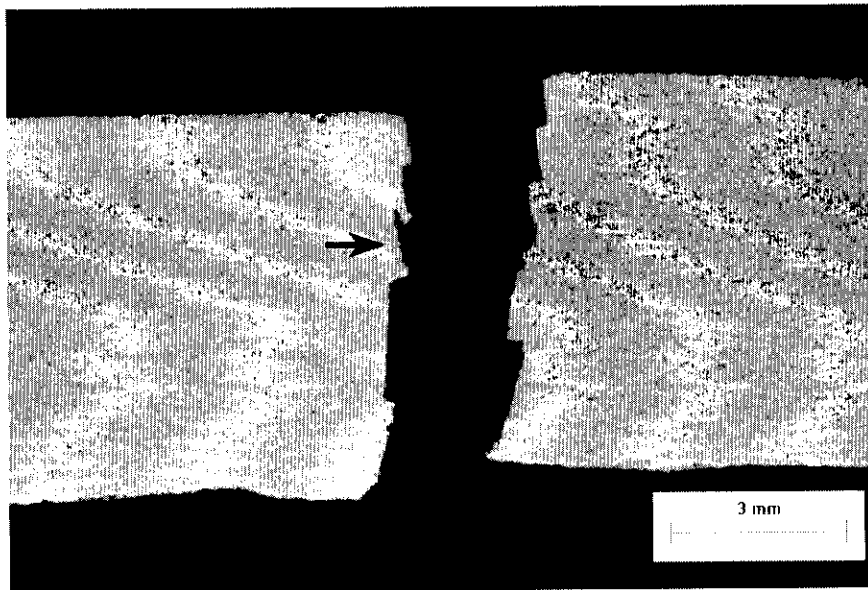
Figure 82

Photograph showing the deepest flaw, which was a hook crack.

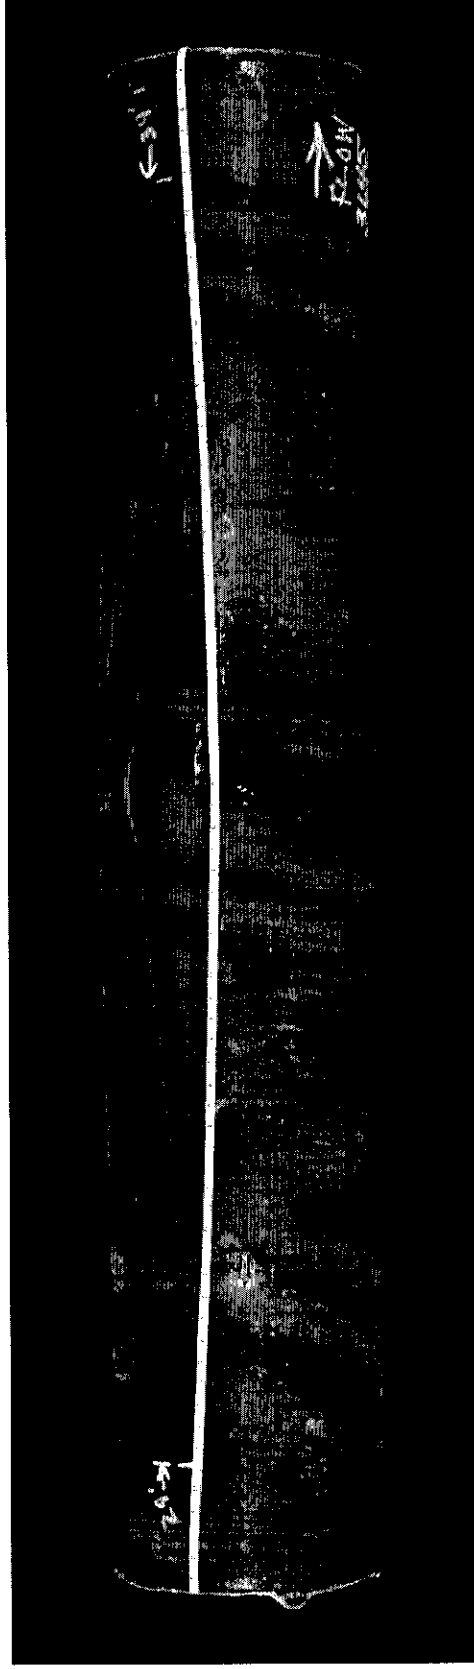
Figure 83 Joint No. 5204 8X
Nital Etch

Matching transverse sections from the hook crack.

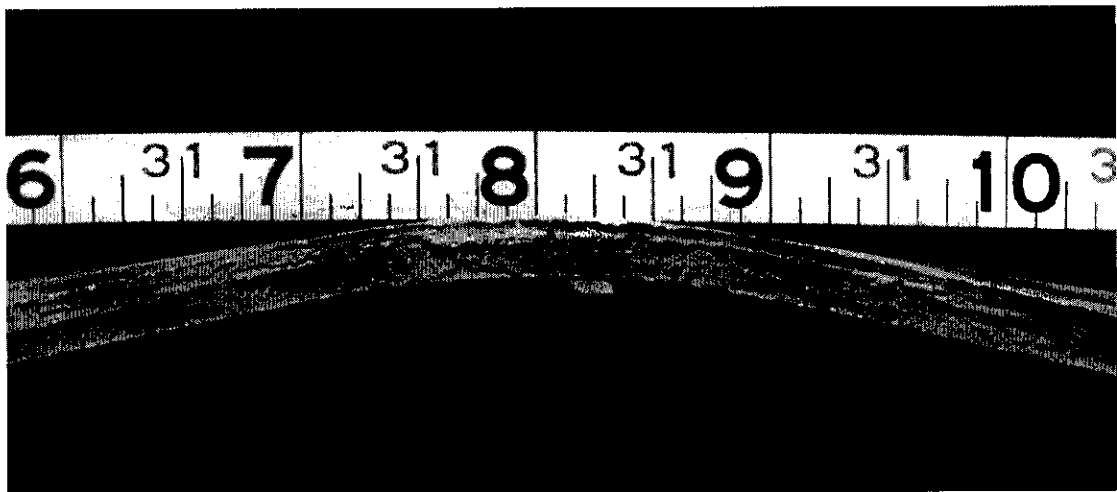
Figure 84

Photograph of the rupture in Joint No. 3645.

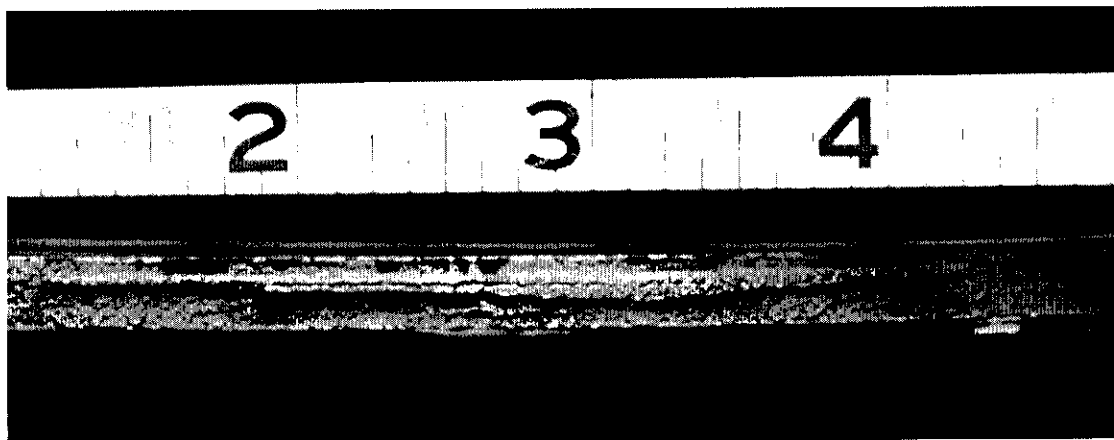
Figure 85 Joint No. 3645

Photograph of a hook crack at the outside surface at the failure origin.

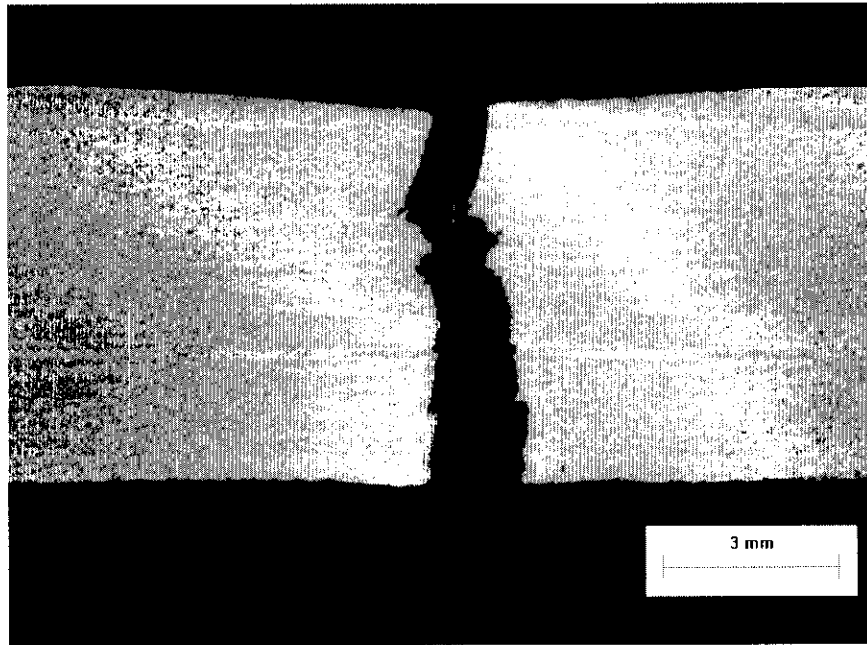
Photograph showing a hook crack at the fracture origin.

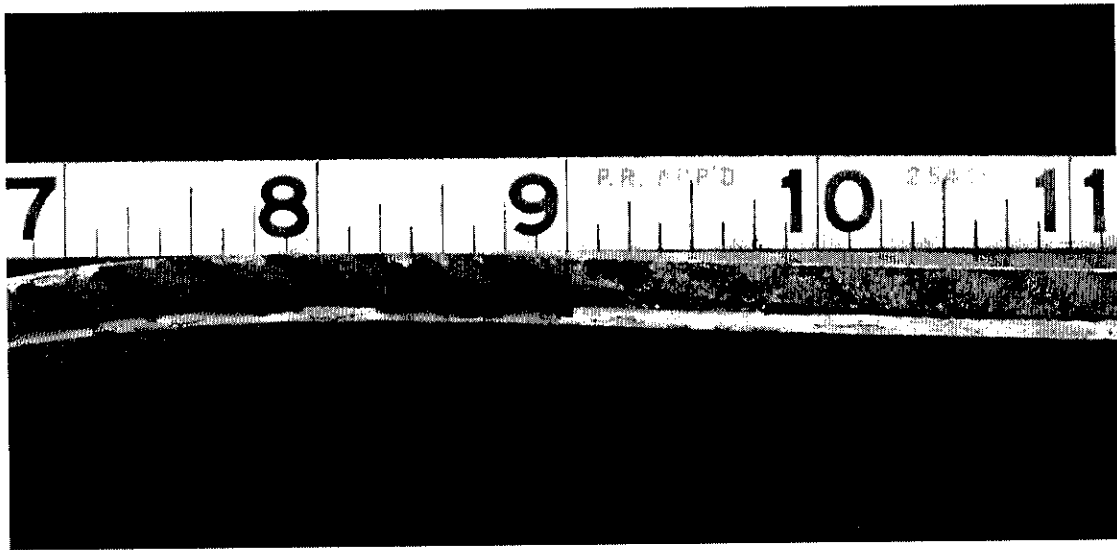
Figure 95

Photograph showing the rupture in Joint No. 7634.
